COUNTRY: UNIDENTIFIED 4 MAY 1966
 SUBJECT: Exploitation of Metallic Fragment from Unidentified Flying Object
 DATE DISR: 4 MAY 66
 NO. PAGES: 2
 REFERENCES: [REDACTED]

FRAGMENT, METAL, RECOVERED IN THE REPUBLIC OF THE CONGO,
BEING BELIEVED TO BE AN UNIDENTIFIED FLYING OBJECT
(COUNTRY UNIDENTIFIED) (U)
MCN-25500

SECTION I. (C) Purpose (U)

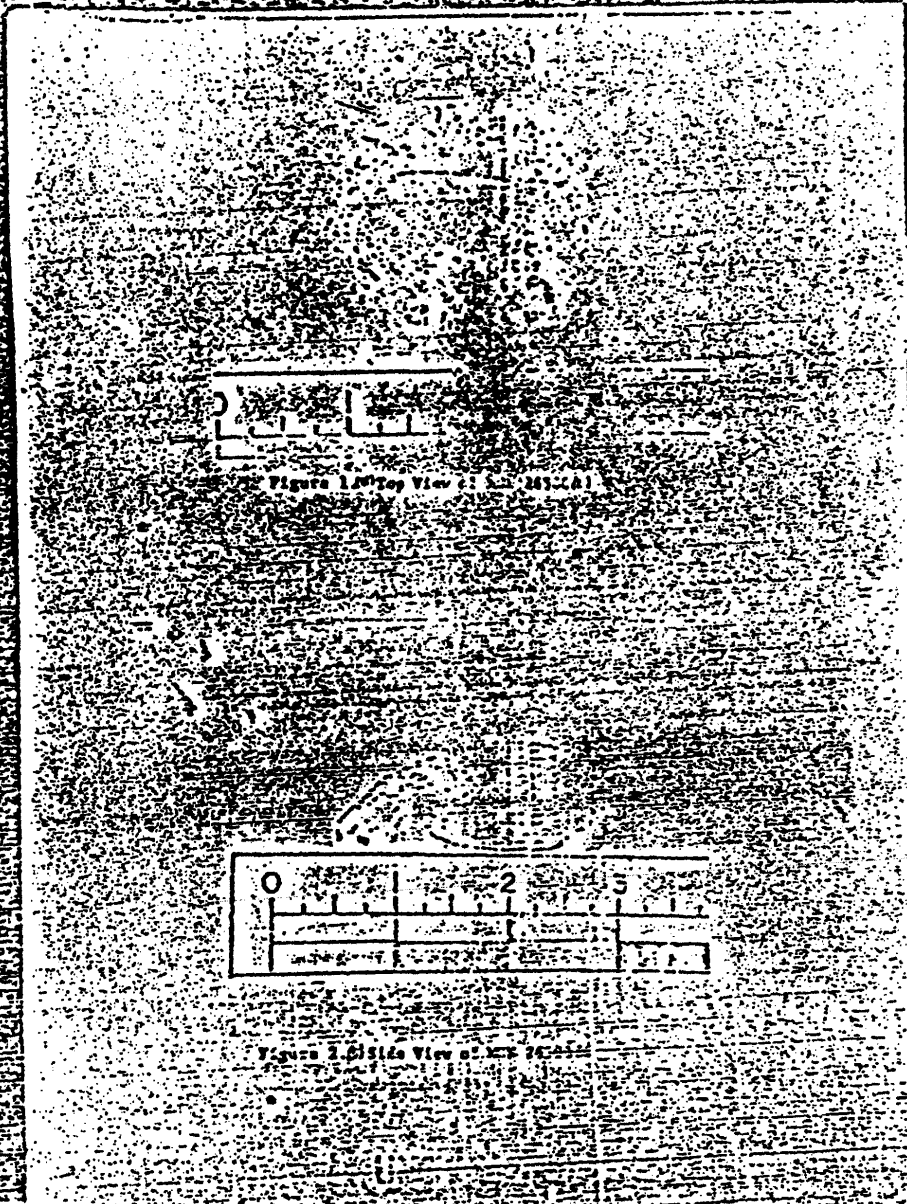
Figure 1. Top View of Lock 200000

2. (C) Details concerning the exact location and characteristics of impact are unknown. However, the appearance of the fragment indicated exposure to high temperatures prior to impact. Examination of the specimen had little effect on its final condition or appearance. The fragment weighed 0.41g and an immediate density of approximately iron and measured 2.25 x 1.75 x 1.0 inches. The top and side views of the specimen were rounded and appeared to have been shaped by heating and melting. This is illustrated in Figures 1 and 2. The V-shaped groove, visible in Figure 1, is the outline of an insert of steel that differs slightly from the rest of the specimen. Figure 3 shows the side view of the end shown in Figure 1.

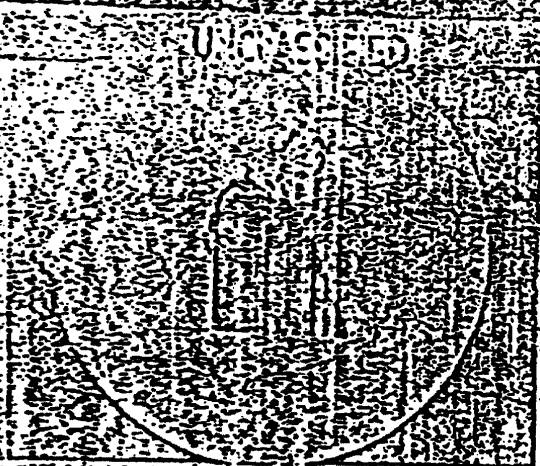
Figure 7. Micrograph Cross-Section of Laminated Area (Magnification 7.7X 6X)

7. (C) The recovered fragment was a silicon steel armature and has a country closely approximating that of the fragment. The metal on heavy oxide was found to have been exposed to temperatures in excess of 2600° F. While there are no indications of impact, the flawed metal, as shown in Figures 4 and 7, would substantiate the conclusion that the item was moving at a high velocity when it was hot.

10. (C) The lamination or stacking of individual laminates is clearly illustrated in Figure 6. The space between laminates on the fin at the top of the photograph is due to the melting and flow of the copper plating during the high temperature exposure of the specimen. Some of the copper has been removed from the fin at the bottom of the photograph. A representative section of this area is shown in Figures 7 and 8.

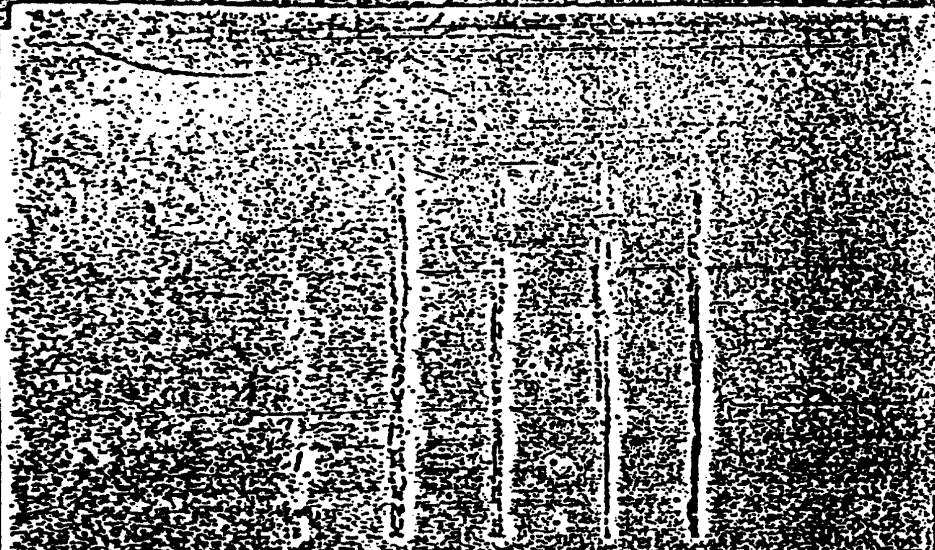
Figure 9. Microstructure of
Laminated Polymer
Regulation of
(C. Nical Etch)

11. (C) Another result of intense heating was the enlarged grain size of the steel laminates' microstructure. The microstructure of the laminates shown in Figures 9 and 10 illustrates grain sizes that are comparable to Company 2 of ASTM Grain Size G. 2. 1000. Large grain size indicates that the steel was heated to a high temperature.

12. (C) The light material between the laminations in Figure 9 is plated copper that melted and flowed between the laminations when the entire specimen was hot. A photomicrograph of this is shown in Figure 11.
