COUNTRY: UNIDENTIFIED 4 MAY 1966
 SUBJECT: Exploitation of Metallic Fragment from Unidentified Flying Object
 DATE DISR: 4 MAY 66
 NO. PAGES: 2
 REFERENCES: [REDACTED]

FRAGMENT, METAL, RECOVERED IN THE REPUBLIC OF THE CONGO,
BEING BELIEVED TO BE AN UNIDENTIFIED FLYING OBJECT
(COUNTRY UNIDENTIFIED) (U)
MCN-25500

SECTION I. (C) Purpose (U)

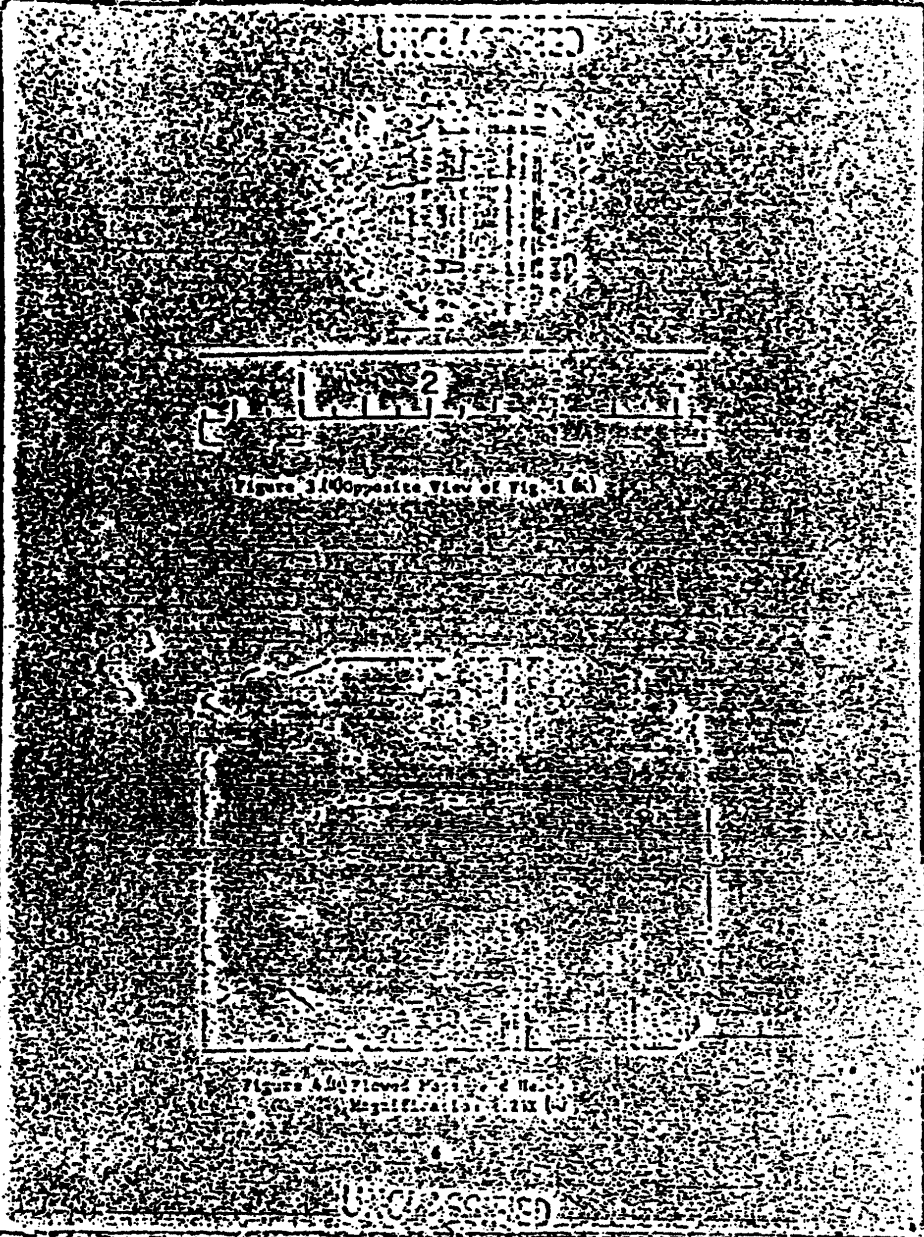
2. (C) Details concerning the exact location and characteristics of impact are unknown. However, the appearance of the fragment indicated exposure to high temperatures prior to impact. Examination of the specimen had little effect on its final condition or appearance. The fragment weighed 0.41g and an immediate density of approximately iron and measured 2.25 x 1.75 x 1.0 inches. The top and side views of the specimen were rounded and appeared to have been shaped by heating and melting. This is illustrated in Figures 1 and 2. The V-shaped groove, visible in Figure 1, is the outline of an insert of steel that differs slightly from the rest of the specimen. Figure 3 shows the side view of the end shown in Figure 1.

Figure 1 Opposite View of Fig. 1 (a)

Figure 2 Opposite View of Fig. 1 (a)
